# THE THREE MAINTENANCE POINTS FOR A RUBBER EXPANSION JOINT

Detect problems early. Plan replacements. Avoid breakdowns.

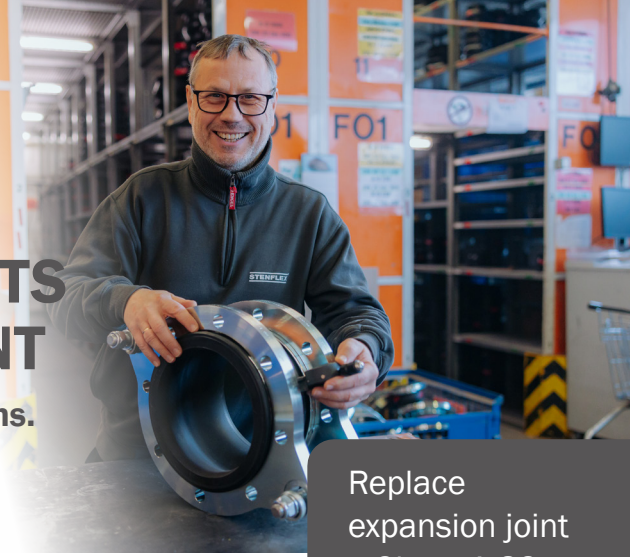
Replace expansion joint  
≥ Shore A 83

The Shore A hardness of the elastomer is an objective indicator of the degree of ageing of the rubber material. We recommend that, once a reading of 83 Shore A or higher is recorded, plans should be made to replace the compensator.
